# Pennsylvania Ave. Water Main Break

## CASE STUDY

Consequences of pipeline failure of an 8-inch water main on the 4700 & 4800 Blocks of Pennsylvania Ave.

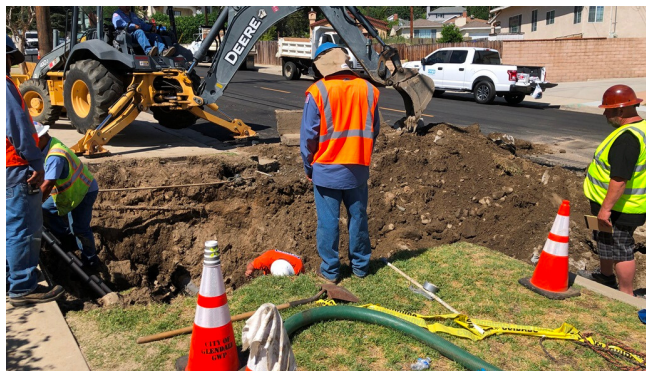
On August 4, 2019, CVWD experienced a major water main break on an existing 8-inch pipeline on Pennsylvania Ave. between El Caminito Street and Stevens Street that was installed in 1946. The water main break started about 2:00 am and water from the pipeline was isolated by 8:00 am. As a result of the water main break:

- 925,000 gallons of water was lost
- 15 homes were without water
- Damage to the plumbing at house near main break.
- Excessive damage to the pavement on Pennsylvania Ave from El Caminito Street to Fairesta Ave.
- Road closure of a portion of the street to traffic
- Increased paving costs as Pennsylvania Ave. was recently repaved by the City of Glendale and there was a five-year moratorium for new construction on the street

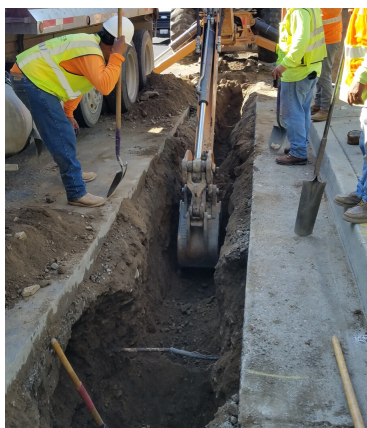
CVWD worked with Los Angeles County and City of Glendale personnel to determine the extent of pavement area that would need to be replaced in the short-term. CVWD contracted with a paving construction contractor to repair the roadway.

Pennsylvania Ave. was repaved and repaired within two weeks after the event and traffic was returned to normal. In addition, CVWD coordinated the pavement work with the start of the 2019-20 school year and provided detour routes for dropping off school children.
